Dam ID: HI00009
Kaawanui

Inspection No: _____
Date: 03/22/2006

STATE OF HAWAII - DLNR
VISUAL DAM SAFETY INSPECTION SHEET

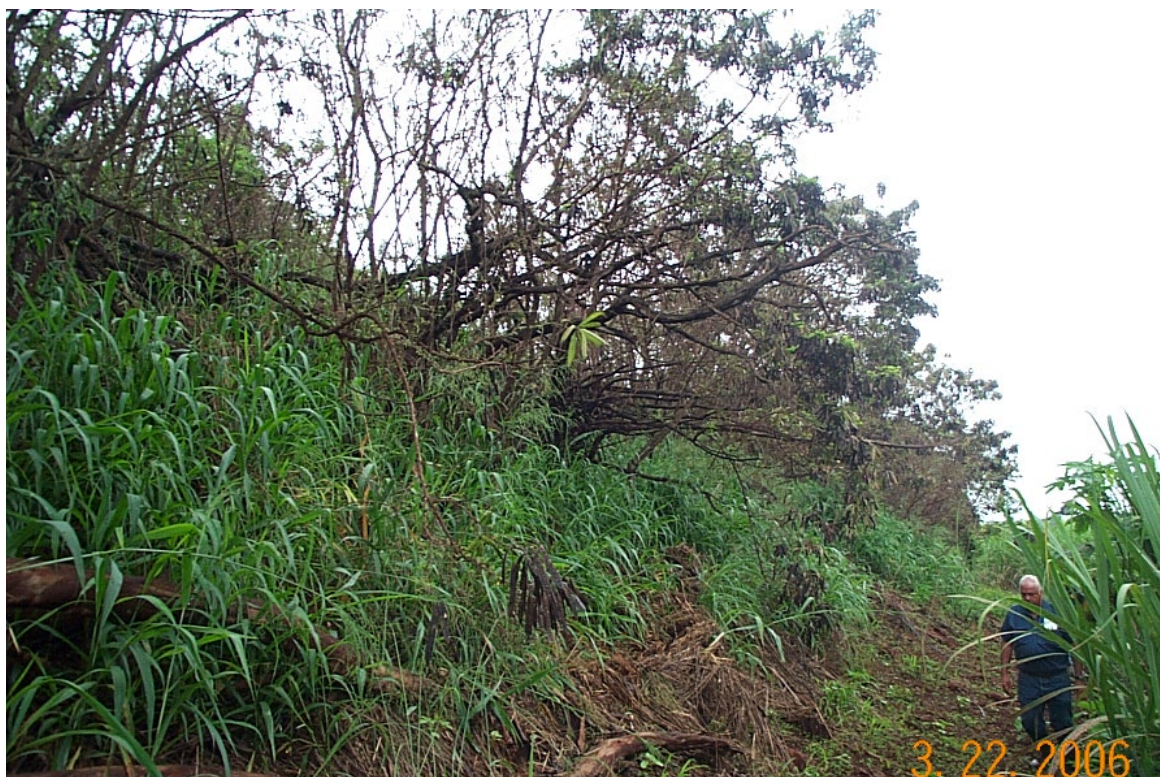
Description: Owner says trees are trimmed every two years. It's time to trim trees.

HI00009 Kaawanui Reservoir: View of downstream slope of dam. Note dense vegetation.

- ☐ j. The slope was very steep, around a 1 to 1 slope, further study is required to verify slope stability.
- ☒ k. Owner should periodically remove vegetation.

1. Owner should continue with removal of vegetation on the upstream and downstream slopes and crest. The slopes should be clear and visible for inspection. If existing trees have been allowed to grow so large in some cases that there is concern that seepage and piping (i.e. internal erosion) along root systems may develop. There is additional concern that cutting and killing the trees will lead to rotten roots and greater potential for such seepage and piping. A more in depth evaluation of the condition should be performed to determine how best to remediate the condition.
2. A path or roadway along the groins, the toe and to the outlet discharge point should be cleared and maintained to facilitate periodic inspection, maintenance, monitoring of seepage conditions, and remediation, if required,
3. Monitor spillway during future high pools and evaluate for possible remediation.

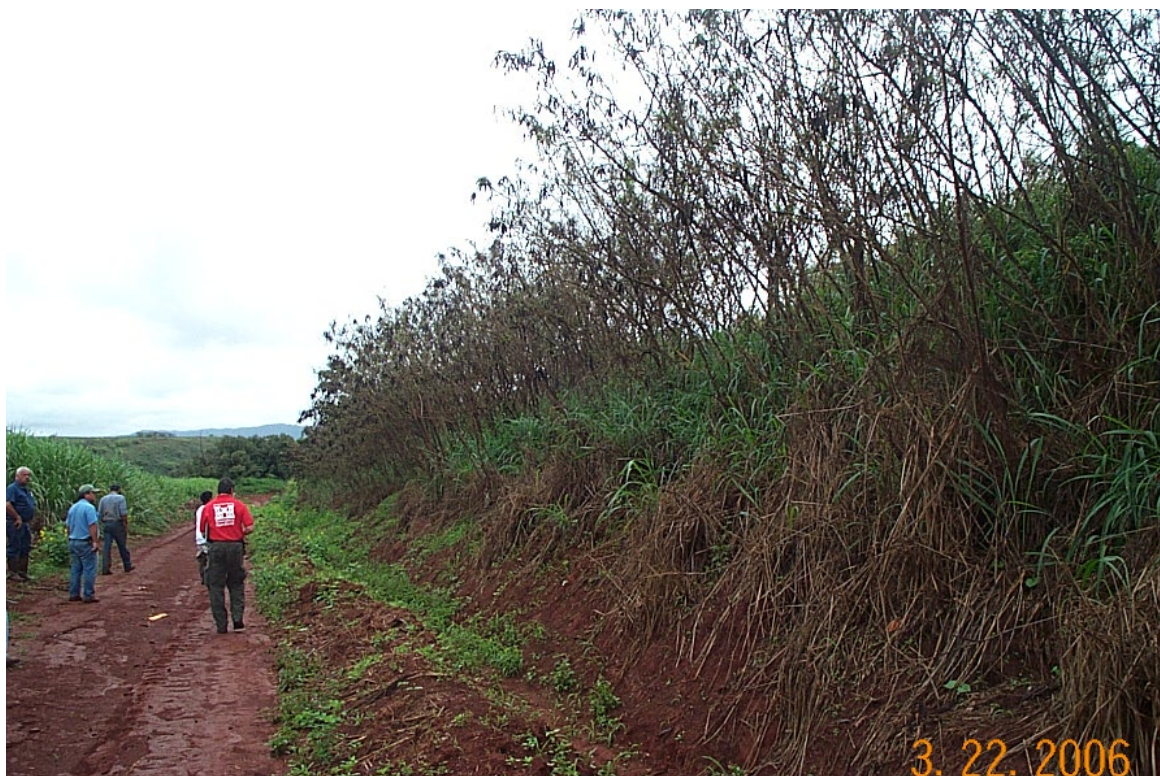
HI00009 Kaawanui Reservoir: View of downstream slope of dam. Note dense vegetation.
